SMOKE TESTING OBSERVATION SUMMARY

Western Run Pilot Project - Baltimore Maryland

**BUREAU OF WATER AND WASTEWATER
SMOKE TEST INSPECTION FORM**

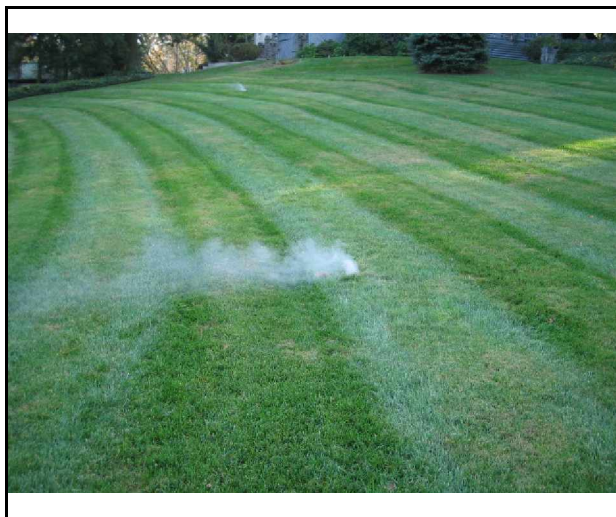
Photo No: 617

Unique Test ID	358	Date:	10/26/2004	MeterBasin:	01_WR09
Observer ID:	A	Crew:	T-3	Dye Test Recommended:	N
Defect No:	4	Setup No:	9	Priority CCTV:

House Number	Street Prefix:	Street Name:	Street Type:		
1701		Regent	ROAD		
Source Type:	04= Cleanout	Location:	7=Yard-Front	Severity:	4=Major
Sector:	2=Private	Drainage Area:	400		
Comments:

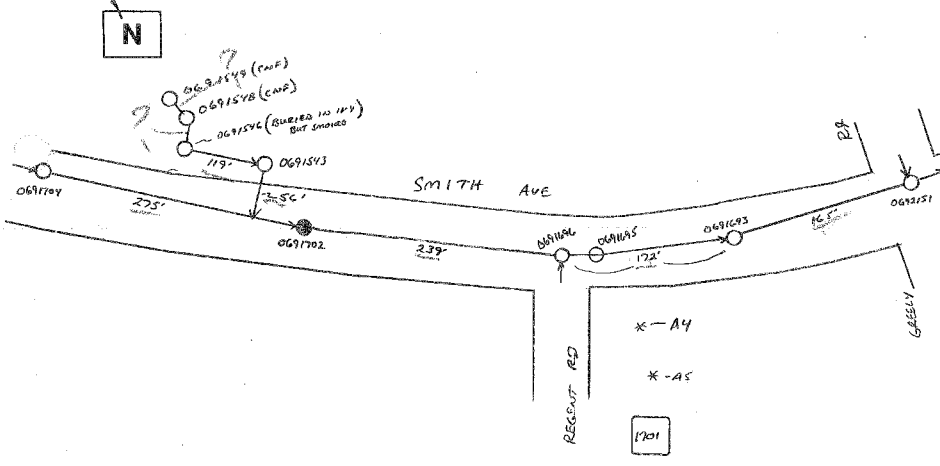
Sketch No: 358

TEST LOCATION			
Project: WRPA	Sewershed: Jones Falls	Date: 10-26-04	Start Time: 1605
Crew: T3	Street Location: SMITH AVE		
US MH: 0691704	DS MH: 0692151	Number of Segments: 6 +	Test Length: 1026'
Plugged US: Y <input checked="" type="radio"/> N	Plugged DS: Y <input checked="" type="radio"/> N	# of Blowers: 1 2 3	Ground: <input checked="" type="radio"/> Dry Moderate Wet
Plugs Removed? Y <input checked="" type="radio"/> N	Recorder: JMM	Comments: CWF 0691545, 0691548, 0691695

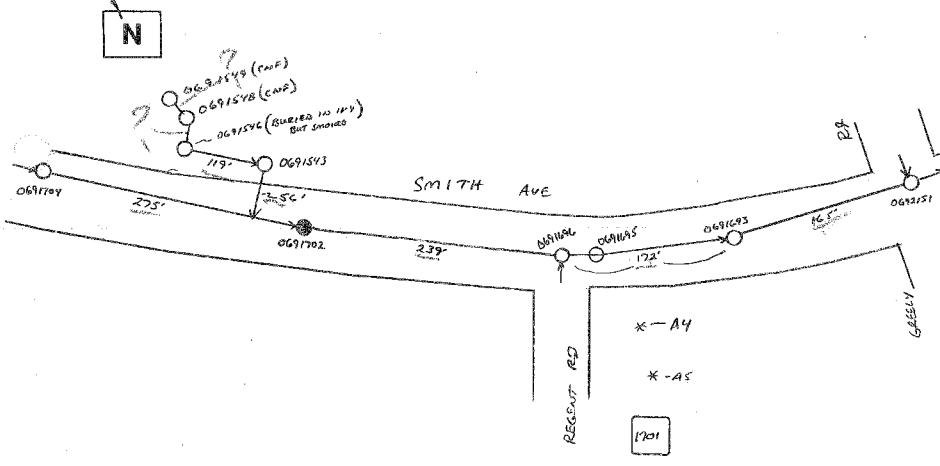
Sketch No: 358

TEST LOCATION			
Project: WRPA	Sewershed: Jones Falls	Date: 10-26-04	Start Time: 1605
Crew: T3	Street Location: SMITH AVE		
US MH: 0691704	DS MH: 0692151	Number of Segments: 6 +	Test Length: 1026'
Plugged US: Y <input checked="" type="checkbox"/> N	Plugged DS: Y <input checked="" type="checkbox"/> N	# of Blowers: 1 2 3	Ground: <input checked="" type="checkbox"/> Dry Moderate Wet
Plugs Removed? Y <input checked="" type="checkbox"/> N	Recorder: JMM	Comments: CWF 0691545, 0691548, 0691695

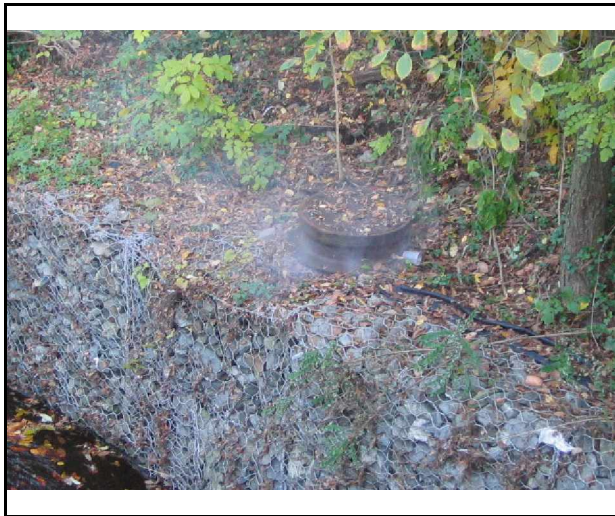
Photo No: 618

Unique Test ID	359	Date:	10/26/2004	MeterBasin:	02_33S
Observer ID:	A	Crew:	T-3	Dye Test Recommended:	N
Defect No:	1	Setup No:	10	Priority CCTV:

Source Type:	12= MH Frame Seal	Location:	11=Field	Severity:	4=Major
Sector:	1=Public	Drainage Area:	200

Comments: MH M1674 - Unmapped manhole

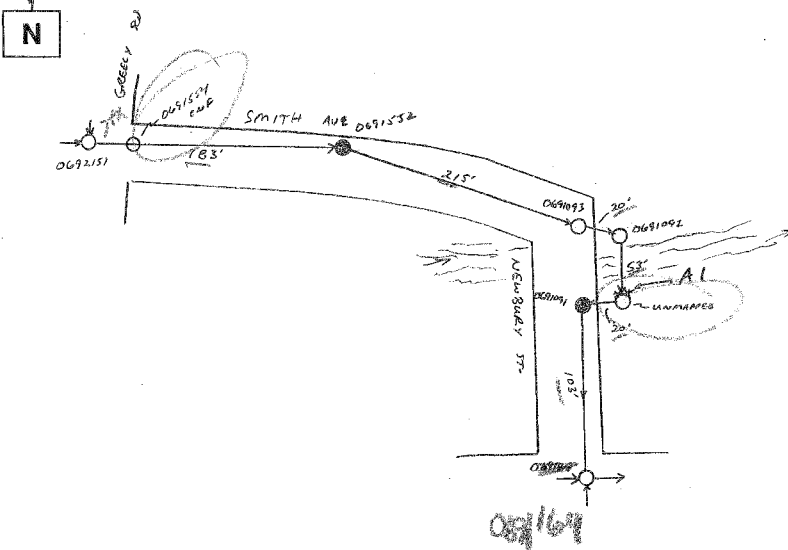
Sketch No: 359

TEST LOCATION			
Project: WRPA	Sewershed: Jones Falls	Date: 10-26-04	Start Time: 1705
Crew: T3	Street Location: SMITH AVE + NEWBURY ST		
US MH: 0692151	DS MH: 0691162	Number of Segments: 1	Test Length: 594'
Plugged US: Y (N)	Plugged DS: Y (N)	# of Blowers: 1 2 3	Ground: (Dry) Moderate Wet
Plugs Removed? Y N	Recorder: [Signature]	Comments: 069155Y CUP

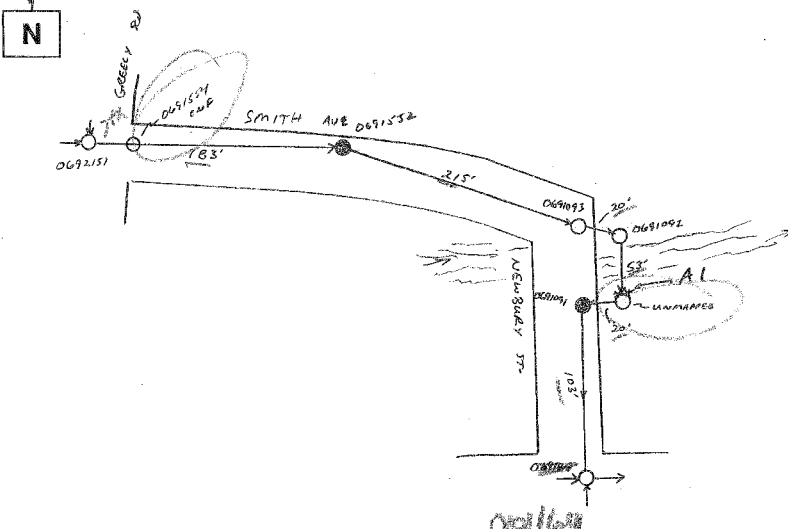
Sketch No: 359

TEST LOCATION			
Project: WRPA	Sewershed: Jones Falls	Date: 10-26-04	Start Time: 1705
Crew: T3	Street Location: SMITH AVE + NEWBURY ST		
US MH: 0692151	DS MH: 0691162	Number of Segments: 1	Test Length: 594'
Plugged US: Y (N)	Plugged DS: Y (N)	# of Blowers: 1 2 3	Ground: Dry Moderate Wet
Plugs Removed? Y N	Recorder: SP22	Comments: 069155Y CUP

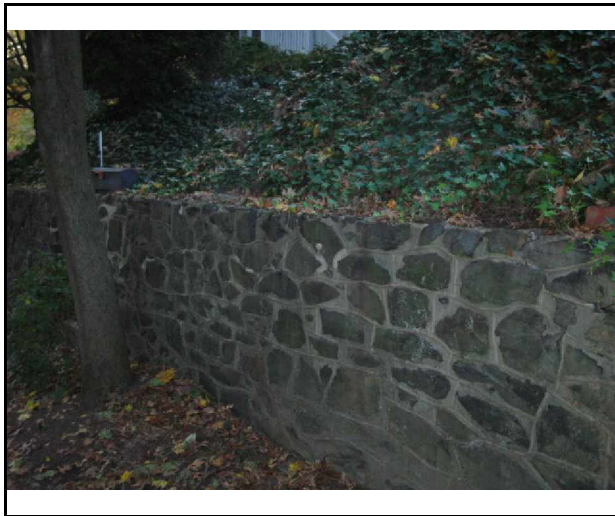
Photo No: 619

Unique Test ID	360	Date:	10/26/2004	MeterBasin:	01_WRR01
Observer ID:	A	Crew:	T-3	Dye Test Recommended:	N
Defect No:	1	Setup No:	11	Priority CCTV:	
House Number	1804	Street Prefix:		Street Name:	
				Fairbank	
				ROAD	
Source Type:	02= Service Line	Location:	7=Yard-Front	Severity:	3=Moderate
Sector:	2=Private	Drainage Area:	200		
Comments:

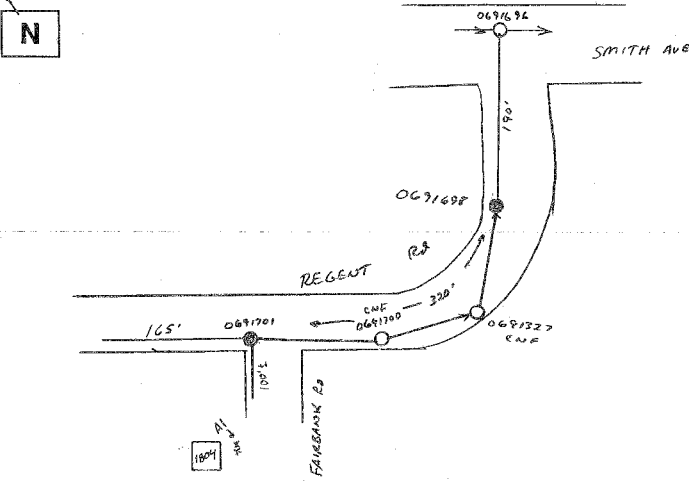
Sketch No: 360

TEST LOCATION			
Project: WRPA	Sewershed: Jones Falls	Date: 10-26-04	Start Time: 1735
Crew: T3	Street Location: REGENT RR + FAIRBANK RD		
US MH: 0691701	DS MH: 0691696	Number of Segments: 6	Test Length: 775'
Plugged US: <u>Y</u> <u>N</u>	Plugged DS: <u>Y</u> <u>N</u>	# of Blowers: <u>1 2 3</u>	Ground: <u>Dry</u> Moderate Wet
Plugs Removed? <u>Y</u> <u>N</u>	Recorder: <u>JMM</u>	Comments: CNF 0691700 OR 0691227

• SMOKE WAS NOT GETTING BETWEEN 0691701 + 0691698, SO WE BLEW SMOKE FROM BOTH.

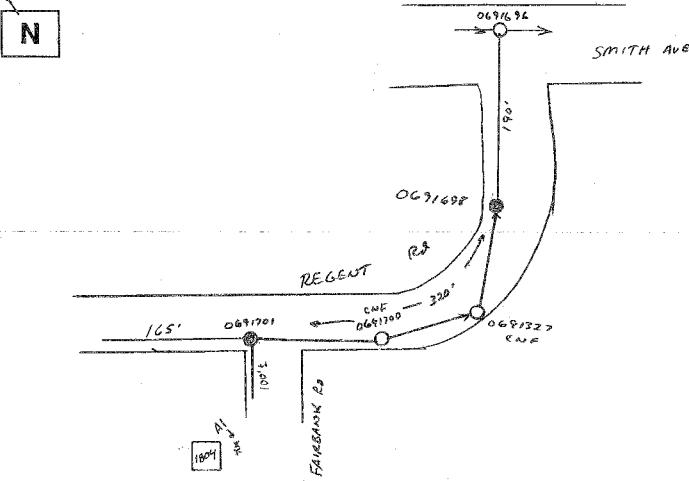
Sketch No: 360

TEST LOCATION			
Project: WRPA	Sewershed: Jones Falls	Date: 10-26-04	Start Time: 1735
Crew: T3	Street Location: REGENT RR + FAIRBANK RD		
US MH: 0691701	DS MH: 0691696	Number of Segments: 6	Test Length: 775'
Plugged US: <u>Y</u> <u>N</u>	Plugged DS: <u>Y</u> <u>N</u>	# of Blowers: <u>1 2 3</u>	Ground: <u>Dry</u> Moderate Wet
Plugs Removed? <u>Y</u> <u>N</u>	Recorder: <u>SMH</u>	Comments: CNF 0691700 OR 0691227

• SMOKE WAS NOT GETTING BETWEEN 0691701 + 0691698, SO WE BLEW SMOKE FROM BOTH.
